RESEARCH MEMORANDUM

INVESTIGATION OF 70 PERCENT TRIMETHYL BORATE - 30 PERCENT
METHYL ALCOHOL FUEL MIXTURE IN A SINGLE J33 COMBUSTOR

AND IN A J33 TURBOJET ENGINE

By Louis J. Schafer, Jr., and Robert O. Hickel

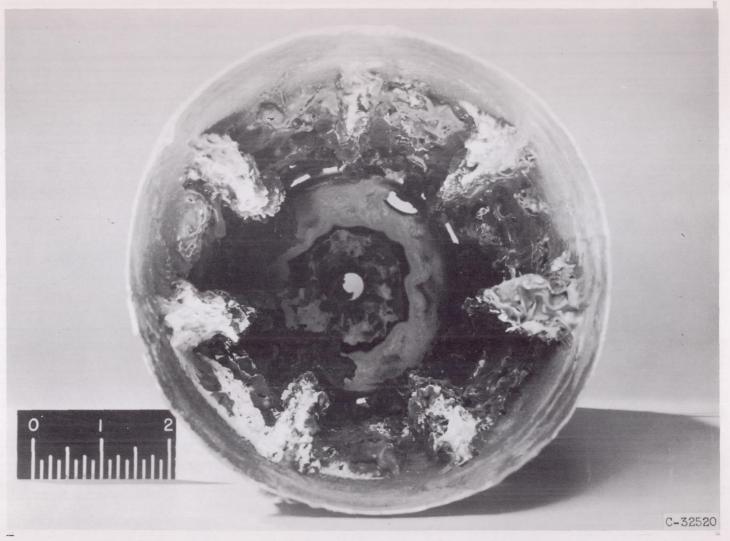
Deposition. - A photograph of the J33 combustor liner and dome assembly after the 2-hour test at condition A (see APPARATUS AND PROCEDURE) is presented in figure 2. Excessive deposits composed of a white powder and a vitreous, amber material were present throughout the combustor and on the ignition spark plug. Less severe deposition occurred in the dome area of the combustor and on the fuel injection nozzle tip. A chemical analysis of both materials indicated a composition of 98 to 99 percent B203. No determination was made for the remaining impurities.

Extreme buildup of deposits generally occurred in areas surrounding the air entry holes of the liner. Since boric oxide solidifies at 842° and 1070° F for the crystalline and vitreous forms, respectively, it appeared that the cooler combustion air entering through these holes solidified the liquid material in the combustor. Because of the nature of the deposition, it is believed that minor combustor modifications, as might be employed to reduce carbon formation, would not result in any appreciable reduction in boric-oxide deposition. Significant reduction might, however, result from a large increase in inlet-air temperature, which would tend to retain the boric oxide in a fluid state.

Figure 2. - J33 single combustor after 2-hour test run with trimethylborate - methyl alcohol fuel blend at condition A.

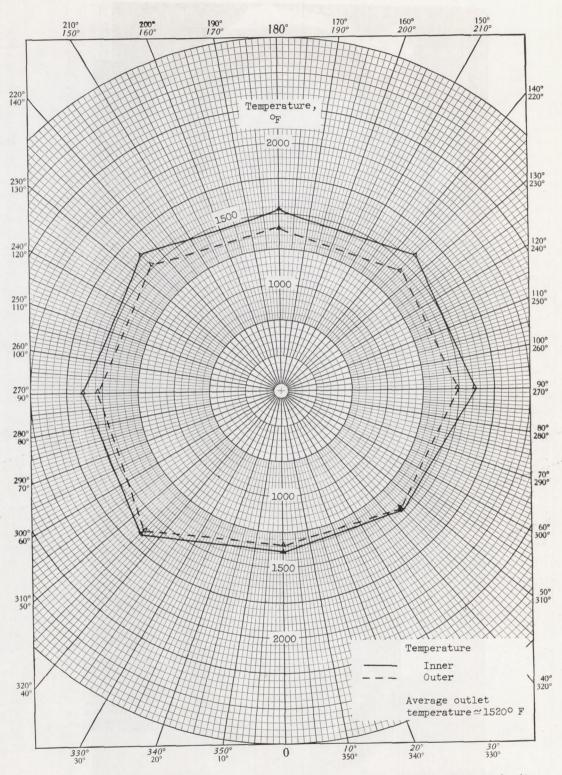
Temperature distribution. - A plot of the exhaust-gas temperature distribution after 1 hour's operation at condition A is shown in figure 3. The data indicate that a relatively uniform temperature distribution exists despite excessive liner deposits. An evaluation of the exhaust-gas temperatures at 1-hour intervals for both test conditions yielded similar, symmetrical distributions.

Figure 3. - Average combustor outlet temperature distribution for J33 single combustor after 1-hour operation with trimethyl borate - alcohol blend at condition A.

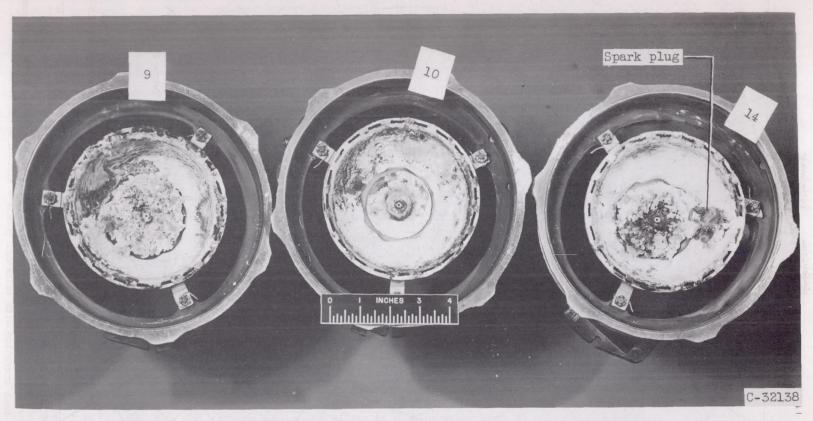
Combustor domes. - The engine used in this investigation has 14 combustors. The domes from combustors number 9, 10, and 14 are shown in figure 4. The deposits in the domes of combustors 9 and 14 are typical of most of the domes. The dome of combustor 14 contains a spark plug. The dome of combustor 10 is shown because it was one of two domes that were relatively free of deposits. The deposits on these parts were partly vitreous and partly crystalline. The crystalline deposits built up to a thickness of about 1/4 inch in some locations on the domes. The air spinner disks were completely plugged with a coating about 1/4 inch thick. The fuel nozzles were imbedded in the deposit on the spinner disks, but the fuel orifices were not closed in any one of the combustors. When the fuel nozzles were disassembled, none of the screens in the nozzles was plugged. There was a heavy deposit of boric oxide on the spark plug shown in dome number 14 but the gap was not closed.

Figure 4. - Boric-oxide deposits on combustor domes and fuel nozzles of combustors 9, 10, and 14.

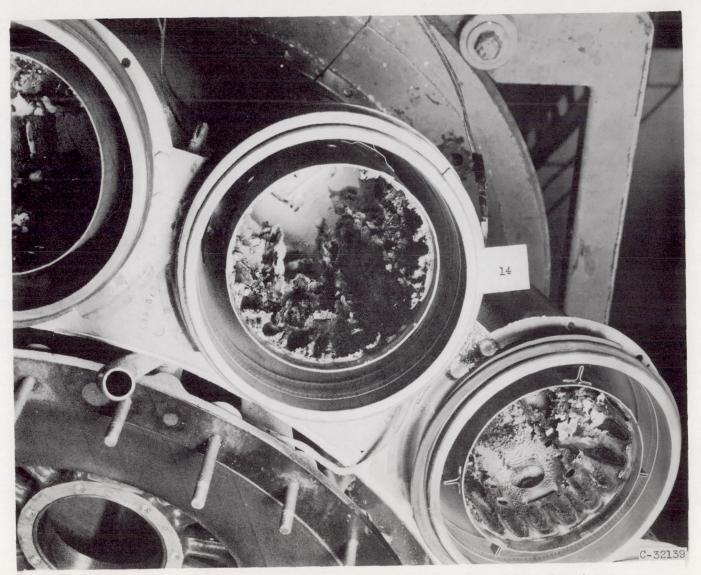
Burner liners. - The deposits formed in the burner liners are shown in figure 5. The deposits in these parts were the crystalline type and in some locations in the liner they built up to a thickness of $l\frac{1}{4}$ inches. Deposits such as this would certainly increase the pressure loss through the combustors and perhaps decrease the combustion efficiency. Toward the exit of the burner liners the deposit was the vitreous type and collected at the exit of the burners in large clumps of boric oxide as shown in figure 6. It appears that redesign of the combustors would be necessary for satisfactory operation of the engine with a high-energy fuel.

Figure 5. - Boric-oxide deposits on combustor liner 14. View looking downstream.

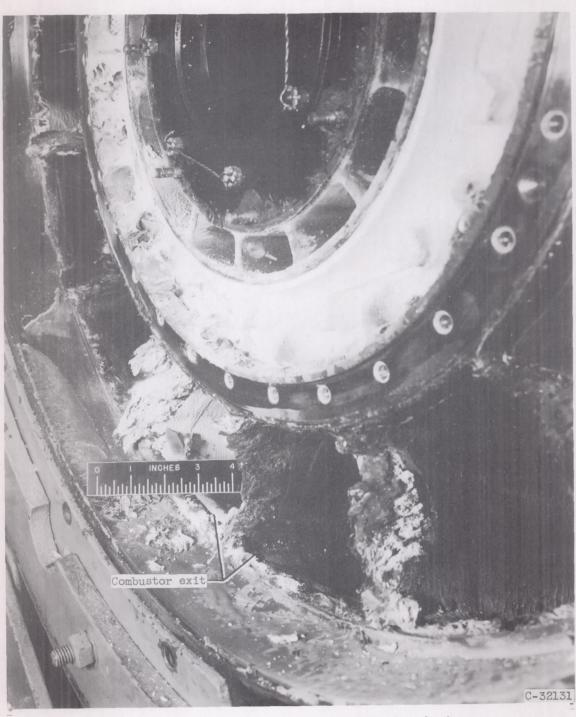
Figure 6. - Boric-oxide deposits at exit of combustors.

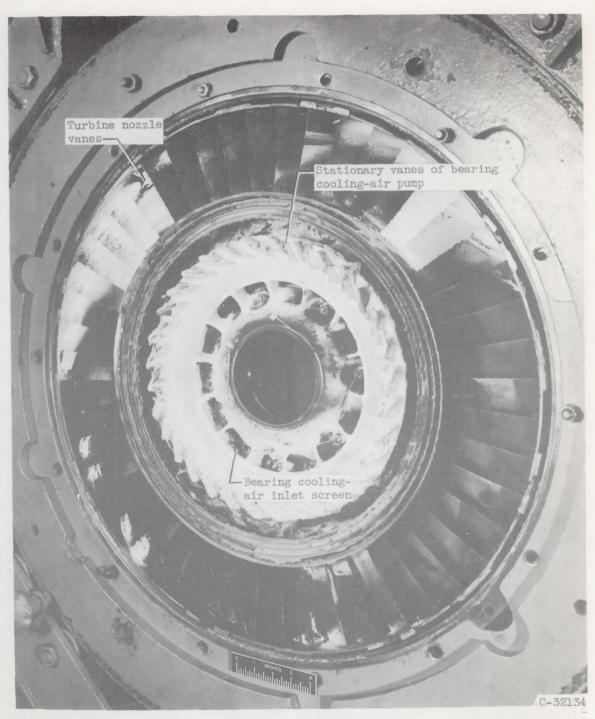
Turbine nozzle diaphragm. - The deposits that collected on the nozzle diaphragm are shown in figure 7. Most of this part was covered with a vitreous coating although there were some nozzle blades that were covered with a white powdery coating. At the locations between adjacent burner liners the build-up of boric oxide extended into the passages between some of the nozzle blades. This deposit would decrease the flow area through the nozzle diaphragm slightly.

Figure 7. - Boric-oxide deposits on nozzle diaphragm and stationary vane of bearing cooling-air pump.

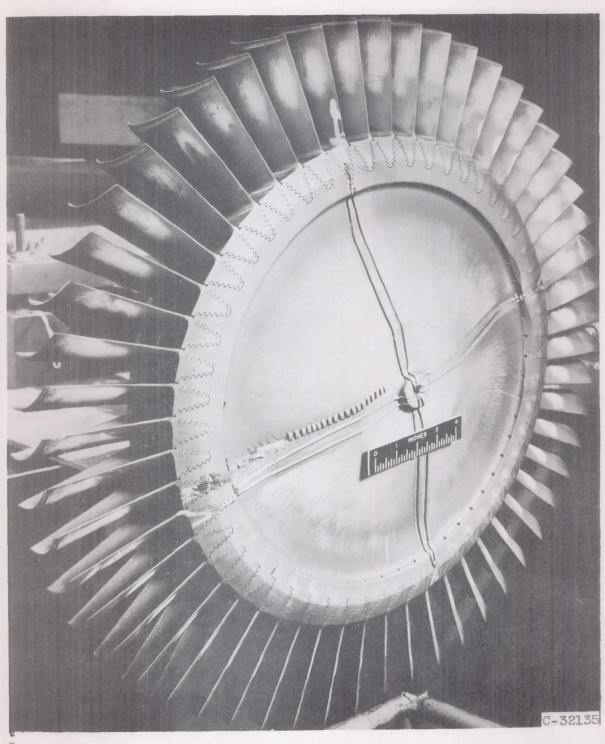
Turbine rotor. - The deposits on the turbine rotor were very similar to those reported in reference 1. The coatings on the rotor blades were thin and vitreous and had radial flow lines on the blade surfaces, showing that the coating flowed along the blade length and was thrown from the blade tips (fig. 8). The turbine disk also had a very thin vitreous coating exhibiting radial flow lines that were similar to those formed on the turbine blades.

Figure 8. - Boric-oxide deposits on turbine rotor and blades.

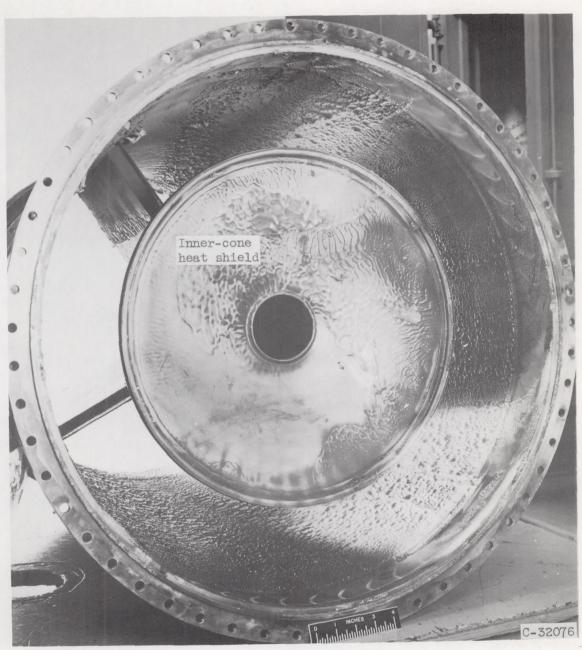
(a) View looking downstream.

Tail cone. - The inside surface of the tail cone was coated with a uniform deposit of the amber-colored vitreous boric oxide, as shown in figure 9. Figure 9(a) is a view looking in the downstream direction. The coating was about 1/4 inch thick. The outside of the inner cone was coated in a similar manner (fig. 9(b)) as well as the heat shield in the inner cone of the tail cone. The deposit on the heat shield must have resulted from the circulation of combustion gas between the turbine rotor and the inner cone.

Figure 9. - Boric-oxide deposits on inner surface of tail cone.

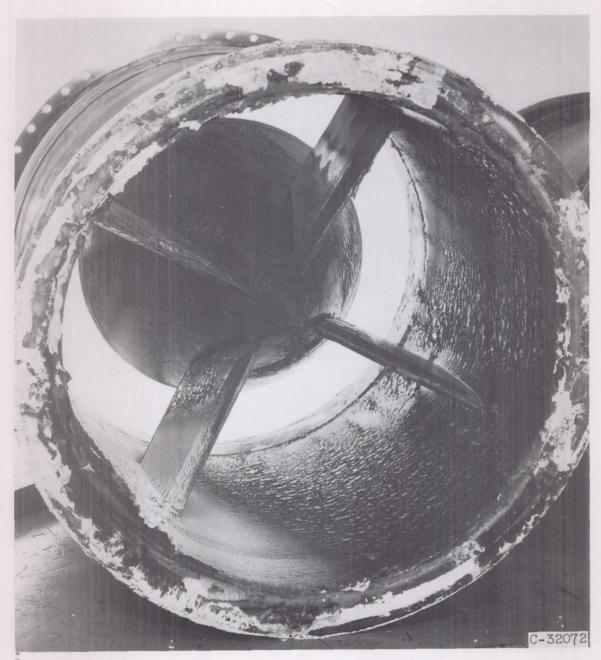
(b) View looking upstream.

Figure 9. - Concluded. Boric-oxide deposits on inner surface of tail cone.

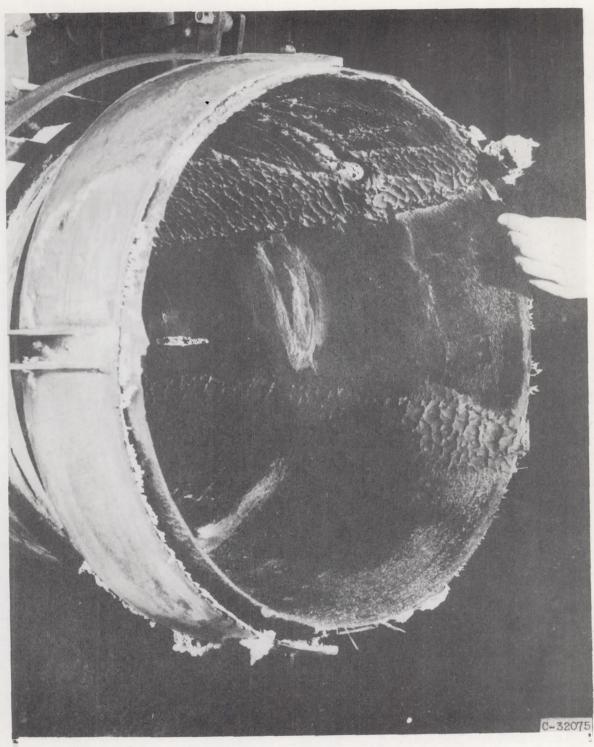
Tail pipe and tail pipe nozzle. - The inside of the tail pipe was covered with a ripply uneven coating of amber-colored vitreous boric-oxide deposit, as shown in figure 10. A maximum deposit thickness of about 1/2 inch was observed. The section of the tail pipe that shows a strip of very thin coating (the right side of the tail pipe in fig. 10) is immediately downstream of one of the struts in the tail cone. There were four such regions in the tail pipe corresponding to the four struts in the tail cone. These areas of thin coating can also be seen in figure 9(b).

Figure 10. - Boric-oxide deposits at exit of tail pipe.

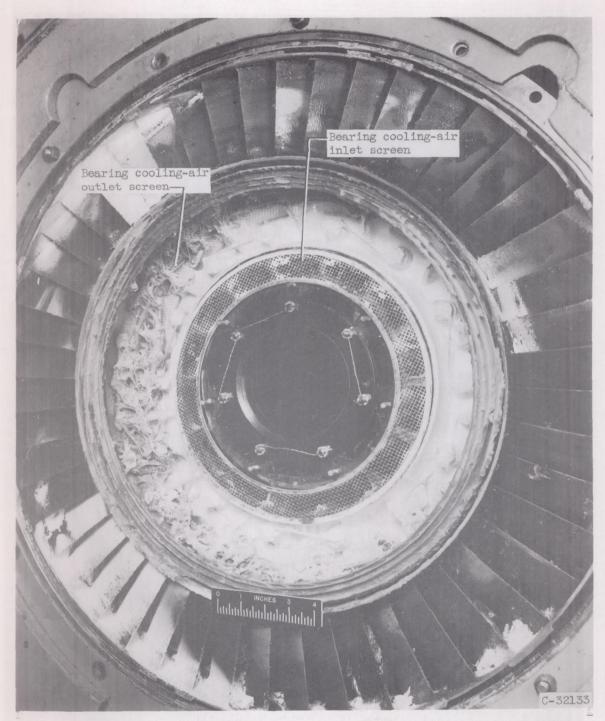
Rear turbine bearing cooling-air screens. - In a J33 engine, the rear turbine bearing is cooled by air which is pumped across the rear bearing housing by a small impeller on the front face of the turbine rotor. The cooling air enters and leaves the air pump through inlet and outlet screens as shown in figure 11. After the air passes through the outlet screen, it is discharged into the space between the combustors and the housing for the compressor and turbine shafts. In flight, the flow of cooling air through the impeller is augmented by the ram pressure existing in the engine nacelle.

In the present investigation, combustion gases leaked radially inward through the gap between the stator and the rotor, and boric-oxide deposits almost completely plugged the cooling-air exit screens as shown in figure 11. This condition may not be as severe in an airplane installation where ram pressure is available, but it is a condition that must be considered in a static installation. After the mixture of bearing cooling air and combustion gases passed through the discharge screens, a white powder was deposited on the outside of the combustors as shown in figure 12. These deposits, though rather thick as shown in figure 12(b), would have no effect on engine performance because they are on the exterior surface of the engine.

Figure 11. - Boric-oxide deposits on outlet screens in bearing cooling-air discharge passages.

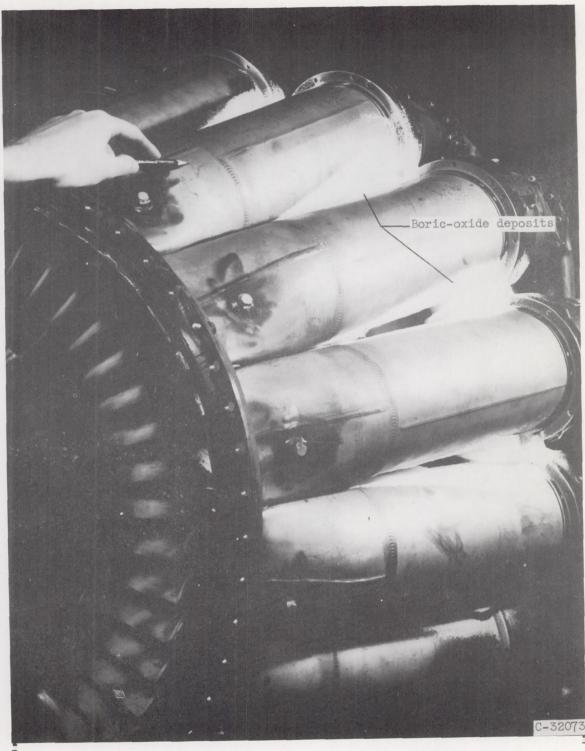
(a) View of combustor surfaces facing radially outward.

The deposits on the turbine blades and rotor disk were not weighed because they were so small they were considered negligible. The amount of deposits on the outside of the combustors (fig. 12) was not determined because this was a very light, powdery form of deposit; furthermore, much of the deposit on the combustors was unavoidably knocked off during disassembly of the engine and the weight would not be accurate.

Figure 12. - Boric-oxide deposits on outer surface of combustors.

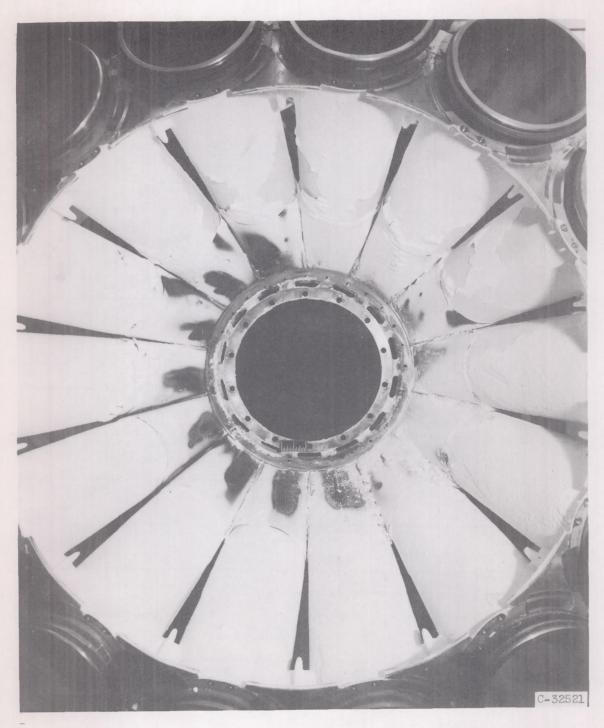
(b) View of combustor surfaces facing radially inward.

Figure 12. - Concluded. Boric-oxide deposits on outer surface of combustors.

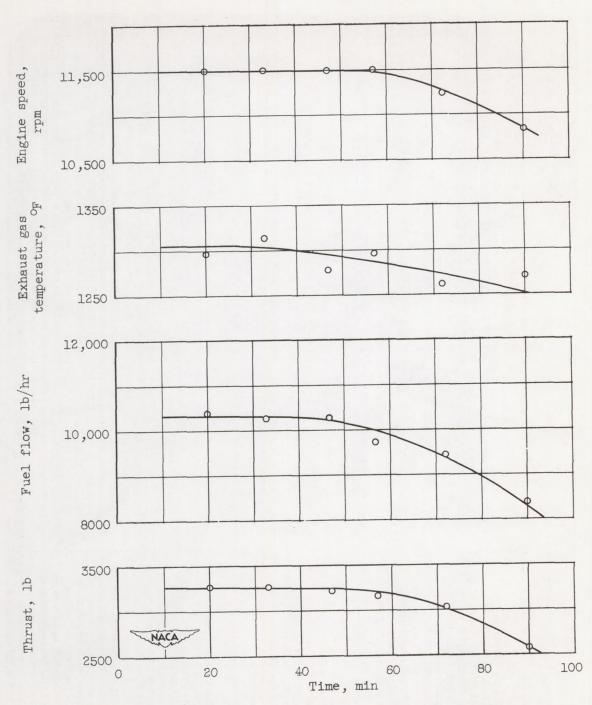
Effect of boric-oxide deposits on engine performance. - The variation of engine performance during the investigation is shown in figure 13, which presents the variation of engine speed, exhaust-gas temperature, fuel flow, and thrust with engine operating time. During the first 45 minutes of operation, there was little variation in engine performance. After 45 minutes of operation, the engine speed, exhaust-gas temperature, fuel flow, and thrust decreased steadily until the fuel supply was exhausted. It was not possible to maintain rated engine speed (11,500 rpm) by increasing the throttle opening, because opening the throttle did not increase the fuel flow. This indicated that there

was a restriction in the fuel lines upstream of the throttle. Prior to the start of this investigation, all fuel filters except one were removed from the fuel system in order to reduce fuel pressure losses to a minimum. At the conclusion of engine operation, the filter was examined and found to have an accumulation of a white powdery substance which apparently clogged the filter to such an extent that the fuel flow was restricted. When the drop in engine speed was observed, it was thought best to continue operation rather than shut the engine down to correct the difficulty because it was felt it might be difficult, if not impossible, to restart the engine once a large amount of deposits had formed within the engine.

No change in the engine performance resulted from the build-up of deposits in the engine during the first 45 minutes of operation. No conclusions can be drawn concerning the effect of deposits on the engine performance after the first 45 minutes when the speed began to decrease because it is not possible to separate the effect of the fuel filter's plugging from the effects of the deposit formation on the engine components.

Figure 13. - Variation of engine performance with operating time when trimethyl borate - alcohol blend was used.
